Manhole Inspection Summary

Manhole # S23GG1005MH

Insp Date: **12/11/06 2:21 PM**

Location Address: **4105 Buena Vista- Edge Hill**

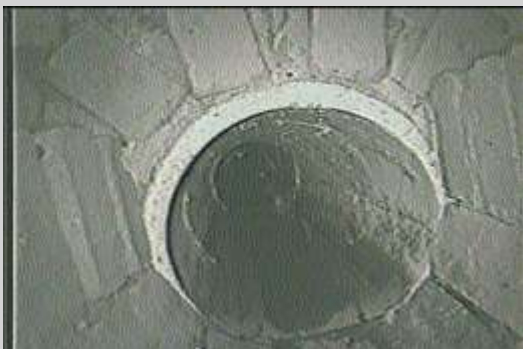
8 in. Circular Gravity Sewer Pipe In @ 3 O'Clock

Rod and Bar (Angled)

Pipe Material: **Clay** ☐ Pipe Lined

Invert Depth: **8.21** (ft.) Flow Characteristics: **Slow**

Deposits: ☒ None ☐ Mud ☐ Sludge ☐ Debris ☐ Grease

Infiltration: **None** Pipe Seal Cond: **Sound**

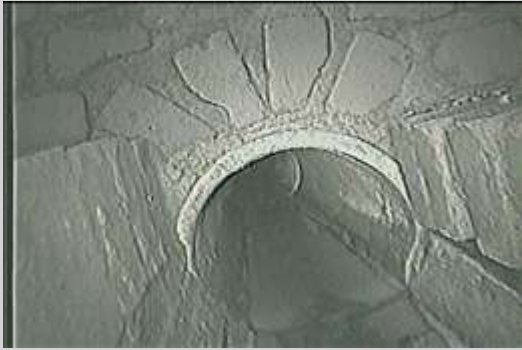
8 in. Circular Gravity Sewer

Rod and Bar (Angled)

Pipe Material: **Clay**

Infiltration: **None**
